# Cavity Walls

## Advantages and Disadvantages of Cavity Walls

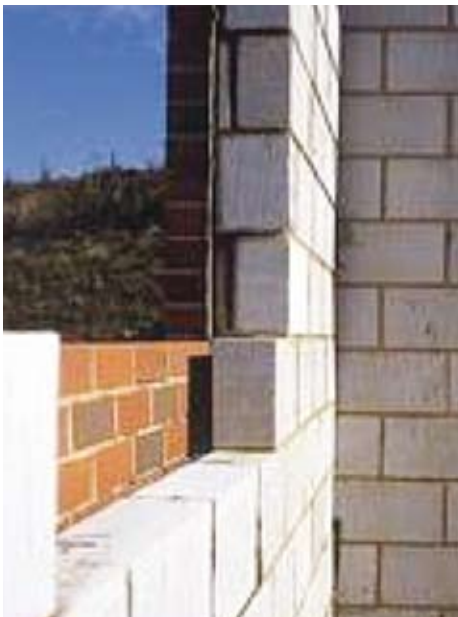
Fig 1 - Modern brick / block cavity wall

Cavity wall construction consists of outer and inner 'leaves' (thin walls approximately 100mm thick) of brick and concrete block respectively, tied together with steel wall ties with a 50- 90mm cavity between them (see Figs 1 & 2). It became common practice in the house building boom of 1920 - 30 and since World War II it has been used almost universally.

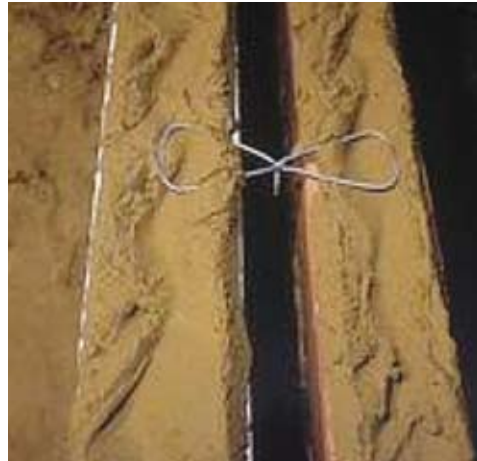
Fig 2 - Wall tie installation

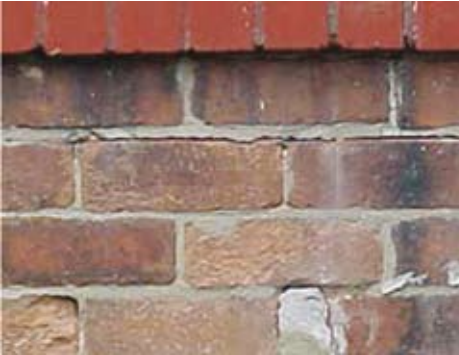
Fig 4 - Horizontal cracking in mortar joint

The main cause of deterioration of cavity walls is wall tie corrosion. If inadequately protected, the steel ties will rust due to the presence of air and water in the cavity. The constituents of mortar droppings can accelerate this process. When steel corrodes it will expand up to ten times the thickness of the parent metal. The ends of the wall ties embedded in the outer leaf will lift the bricks above, causing a horizontal crack to appear in the mortar joint (see Fig 4).

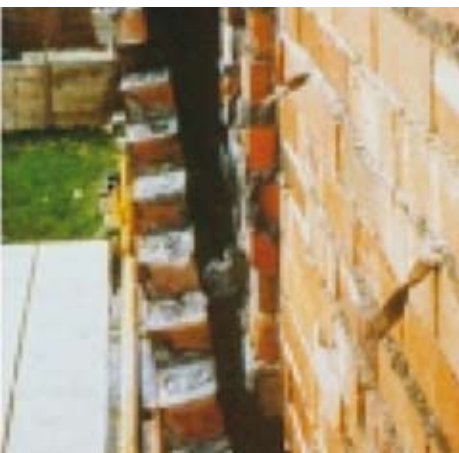
Fig 5 - Separation of outer leaf

In extreme cases, the outer leaf can become separated from the inner leaf and fall off (see Fig 5). However, it must be stressed that this very rarely leads to any further collapse of the wall, and so there is no immediate threat to the safety of the occupants of the property.
