Sulfate damage to concrete floors on
sulfate-bearing hardcore
Identification and remediation

Ian Longworth, MSc(Eng), CGeol, CSci,
BRE Associate, Materials and Engineering Group,
Building Research Establishment

February 2008
Department for Communities and Local Government

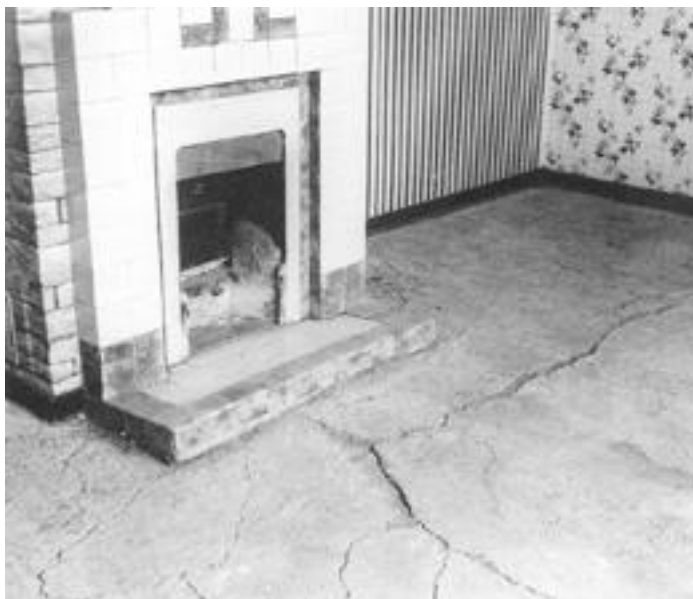
Figure 1: Distortion and cracking of a concrete floor slab caused by sulfate attack. Damage is greatest in front of the fireplace where water, carrying sulfates from underlying hardcore, has been drawn through the slab by heat from the fire.

Sulfate-bearing hardcore, derived from colliery spoil and other industrial by-products, was included in the construction of many thousands of domestic properties in the period 1945–1970, as support for concrete floor slabs, without the use of a separating damp-proof membrane. The legacy has been a continuing occurrence of damage to floor slabs and abutting walls as sulfate from the hardcore has reacted with the overlying concrete resulting in cracking, expansion and deformation. Figure 1 shows typical damage to a floor slab in a house built in the 1950s.

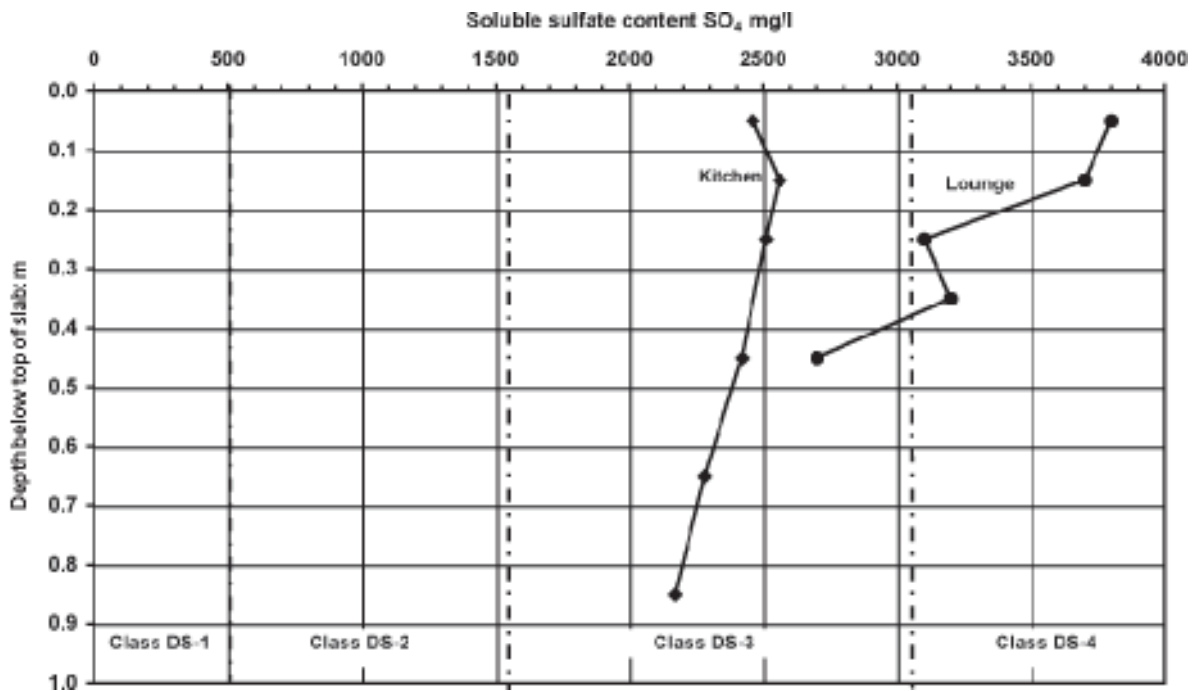
Figure 3: Water-soluble sulfate contents in burnt colliery spoil (red shale) sampled at depths below a concrete floor slab in a 40 year old house. Also shown are the Sulfate Class Limits from BRE SD1:2005. The profiles show values of sulfate which increase upwards. This is likely to be due to these soluble sulfates being drawn upwards by water passing through the slab to the warm rooms above.

Figures 2 and 3 show sulfate contents measured by the Building Research Establishment (BRE) in burnt colliery spoil (red shale) hardcore sampled at

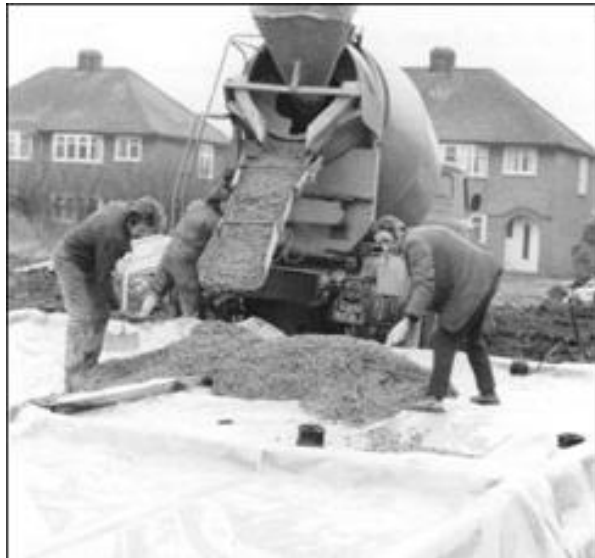
Figure 4: Laying of concrete in the mid 1970s on a 300 micron damp-proof membrane that has been placed over hardcore in the foundations of a house.

- Sulfate migration from hardcore into concrete may be prevented by the use of a separating membrane. Polythene sheets, installed primarily as a damp-proof membranes (DPM), began to serve this purpose from the mid 1960s, and became almost universal for concrete slab construction on sulfate-bearing hardcore by the early 1970s. DPMs installed in the 1960s were typically only 500 gauge (125 micron) thick, and doubts have been cast by some practitioners on their effectiveness as a barrier to sulfate migration. However, no case of deleterious sulfate attack where such a membrane was installed has been brought to the attention of BRE. Thicker membranes that are more resistant to perforation during installation were installed in later decades (eg Figure 4), the current standard being 300 micron.

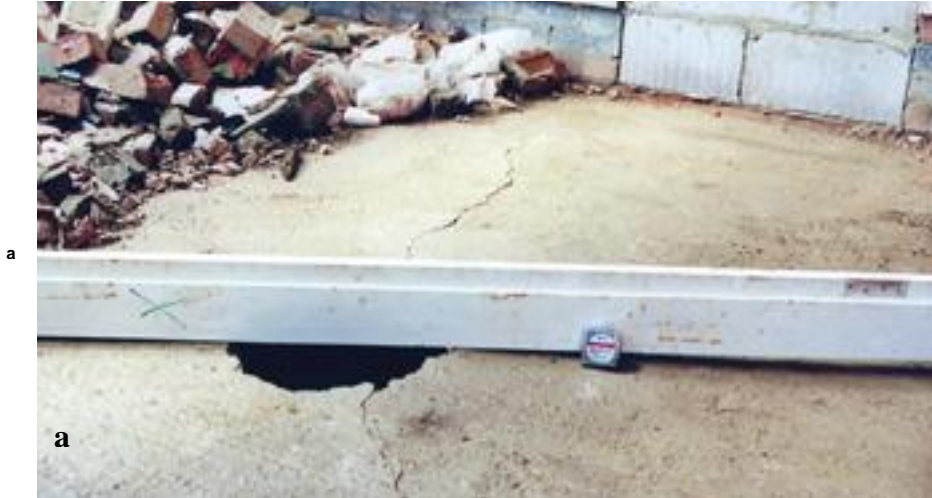
Figures 7(a, b & c): Sulfate-attacked oversite concrete that was laid over plaster contaminated brick rubble beneath a suspended wooden floor (here removed together with the sleeper walls).

(a) An improvised straight edge shows some 50 mm doming of the oversite concrete that lifted brick sleeper walls and wooden floors.

Figures 7(a) to 7(c) show sulfate attacked oversite concrete that was laid over plaster contaminated brick rubble beneath a suspended wooden floor of a bungalow in the West Midlands. The concrete, much softened as result of TSA, domed upwards in several rooms lifting the sleeper walls that supported the floor. The doming was accompanied by radiating and map pattern cracks.

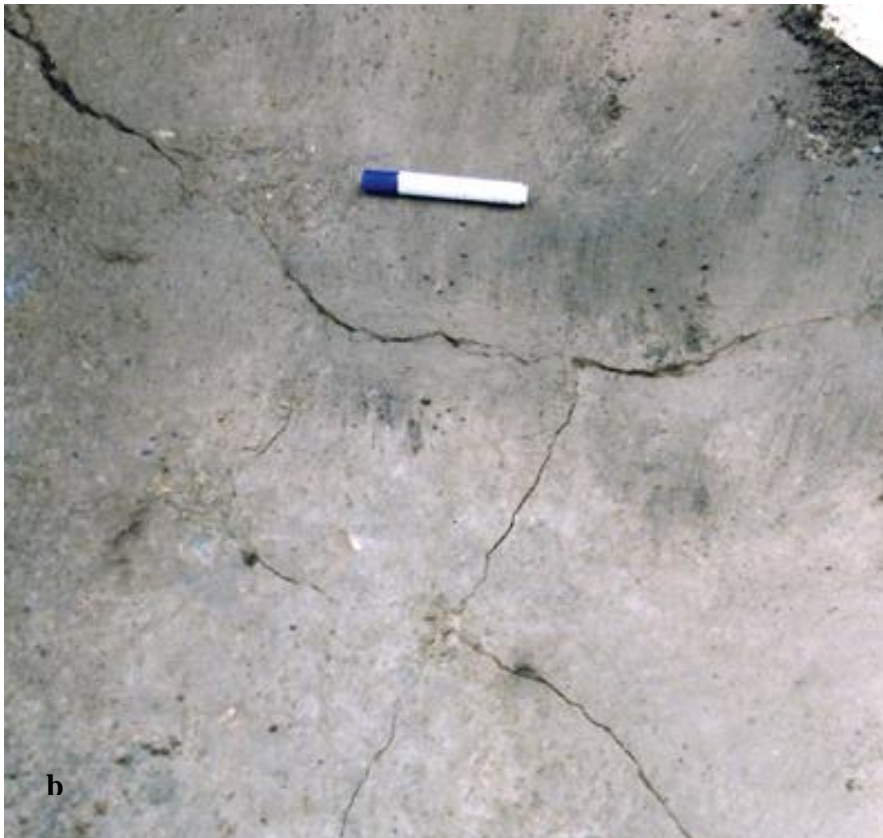
(b) Map pattern cracks in sulfate-attacked oversite concrete beneath a suspended wooden floor of an adjacent room.

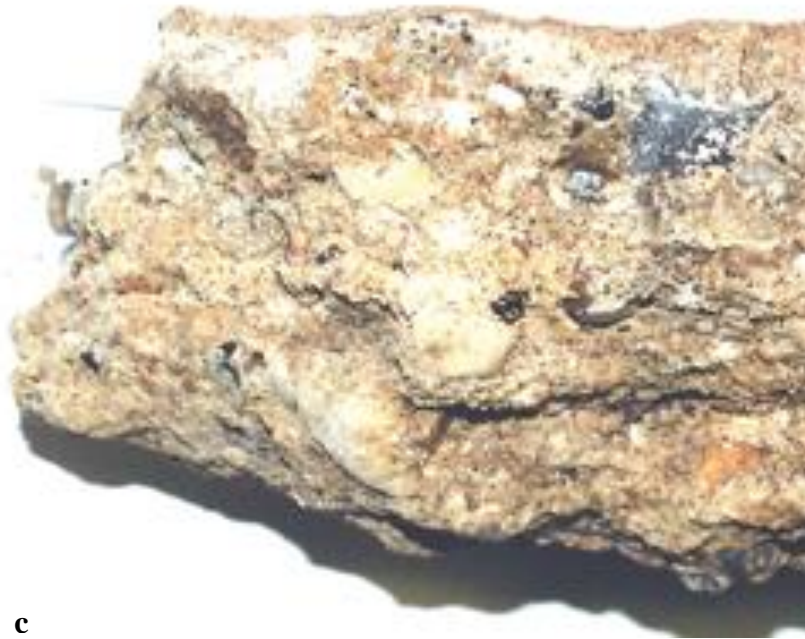
c

- (c) 70 mm thick sample of oversite concrete affected by TSA. The concrete has been softened and discoloured white and yellow-brown. Much white thaumasite can be seen in the upper part of the section. Concrete missing from the bottom of the section was so friable it fell away during sampling.

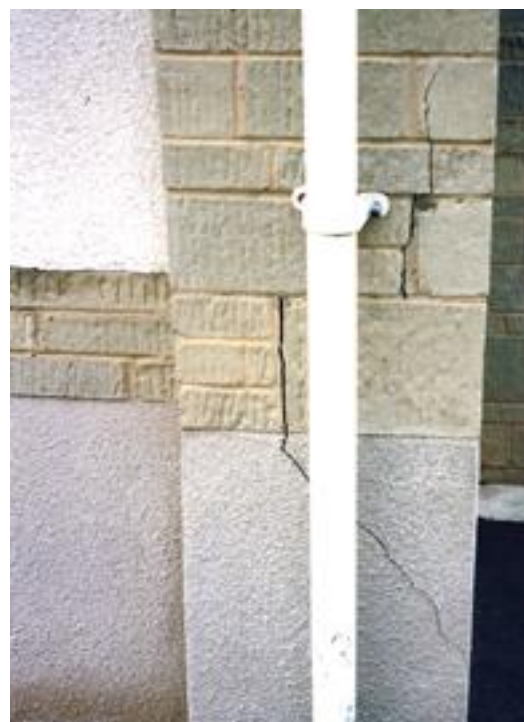
Figures 8(a & b): Exterior of a bungalow affected by sulfate attack in South Wales. The worst damage is on the downslope side where there is about 1 m of exposed masonry below internal floor level.

- (a) Wall below DPC level (arrowed) has been thrust outward by 5 mm by sideways expansion of the floor slab.
- (b) Masonry at a corner, above and below DPC level, has been disrupted by outward thrusting of floor slab.

Externally, the pushing out of walls by the sideways expansion initially causes horizontal cracks to appear in mortar courses at or near to DPC level. With time these typically show a horizontal step in the masonry with the courses above being thrust out (oversailing) relative to the courses below. There may also be irregular displacement of blocks of the wall adjacent to the DPC particularly near to corners, as in Figures 8(a) and 8(b).
